Yongbyon: A Better Insight into the Status of the 5MWe Reactor

By David Albright and Serena Kelleher-Vergantini

April 29, 2015

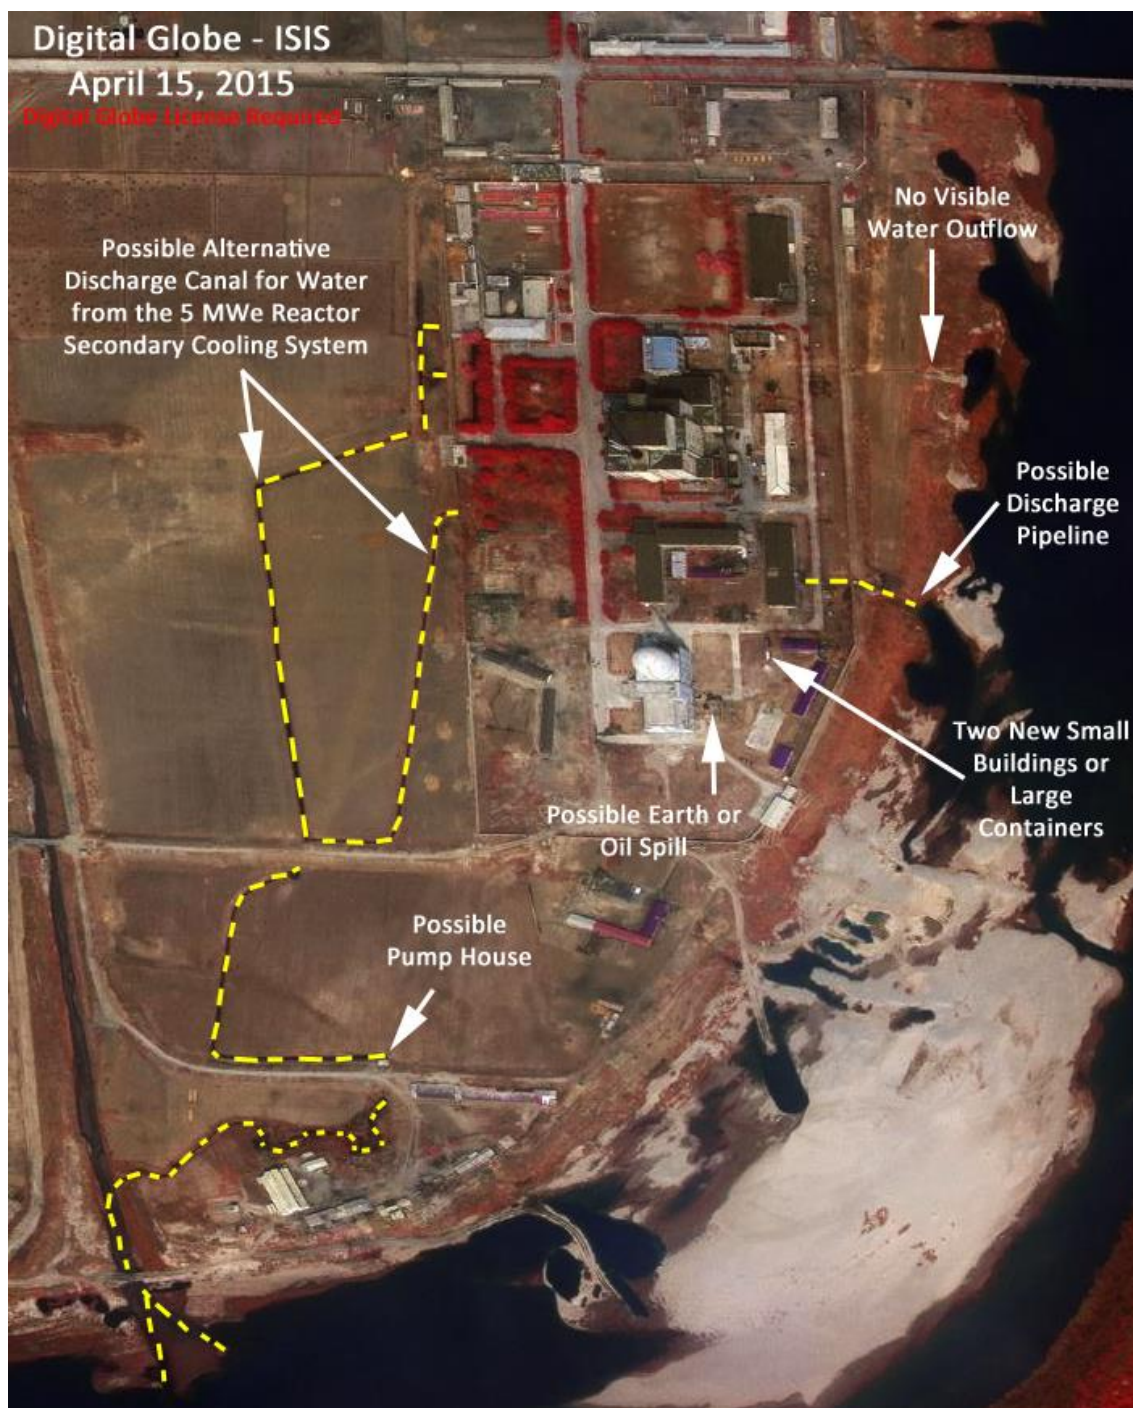
Based on the analysis of recent imagery, two possible discharge locations are noted. The first one can be seen in January and February 2015 winter images and is located slightly down river from the known discharge point on the river bank (see figure 1). Its exact purpose, however, is unknown. It is plausible that this pipeline may be connected to the other activities at the reactor site.

Figure 1. Digital Globe imagery showing North Korea's Yongbyon 5 megawatt-electric (MWe) and experimental light water reactors on April 15, 2015. This is a color infrared image in which healthy vegetation appears red.

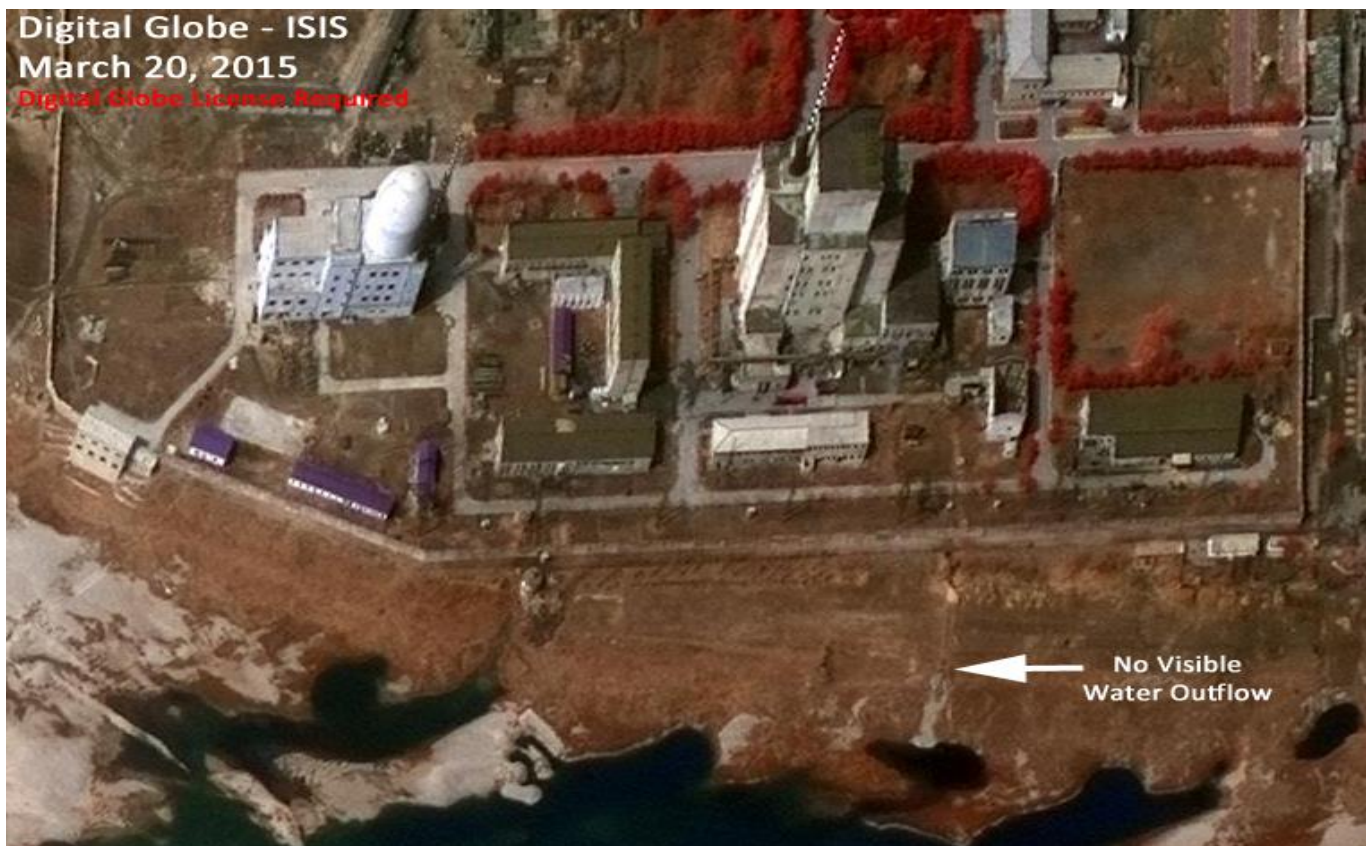
system is active. The secondary cooling system intakes water to cool the carbon dioxide gas heated by the reactor's operation. However, determining whether it is active for low power operation or simply operating intermittently is not possible from the image. In the March 20 and April 15, 2015 images, an outflow of water is not visible at the discharge point mentioned above. But a weak stream of warm water could be present but not visible without the presence of ice and snow.

Figure 2. Digital Globe imagery showing North Korea's Yongbyon 5 megawatt-electric (MWe) and experimental light water reactors on March 20, 2015. This is a color infrared image in which healthy vegetation appears red.

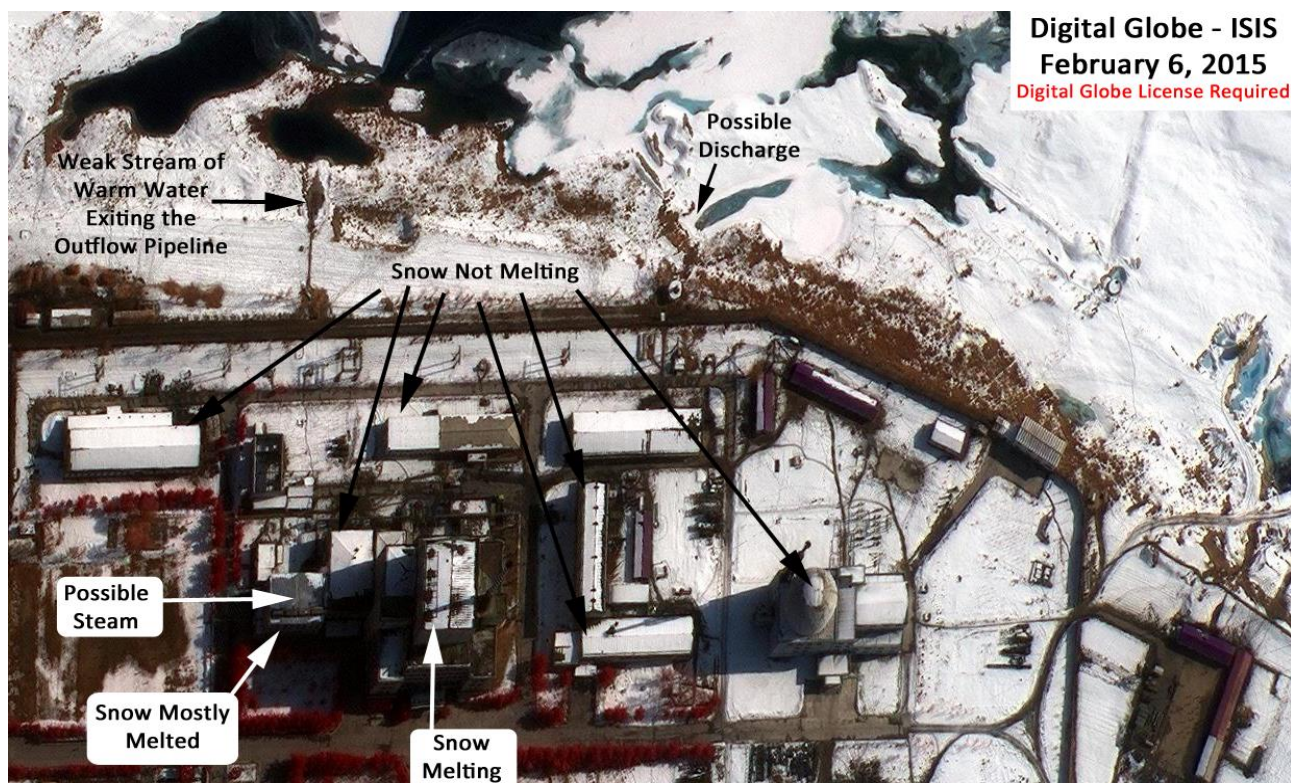
Another piece of evidence possibly suggesting operation involves the turbine building which may be emitting steam at the time of the February 6, 2015 image. There is an irregular white shape, consistent with a small batch of steam, visible on the turbine building roof beside the two original vents.

Figure 3. Digital Globe imagery showing North Korea's Yongbyon 5 megawatt-electric (MWe) and experimental light water reactors on February 6, 2015. This is a color infrared image in which healthy vegetation appears red.

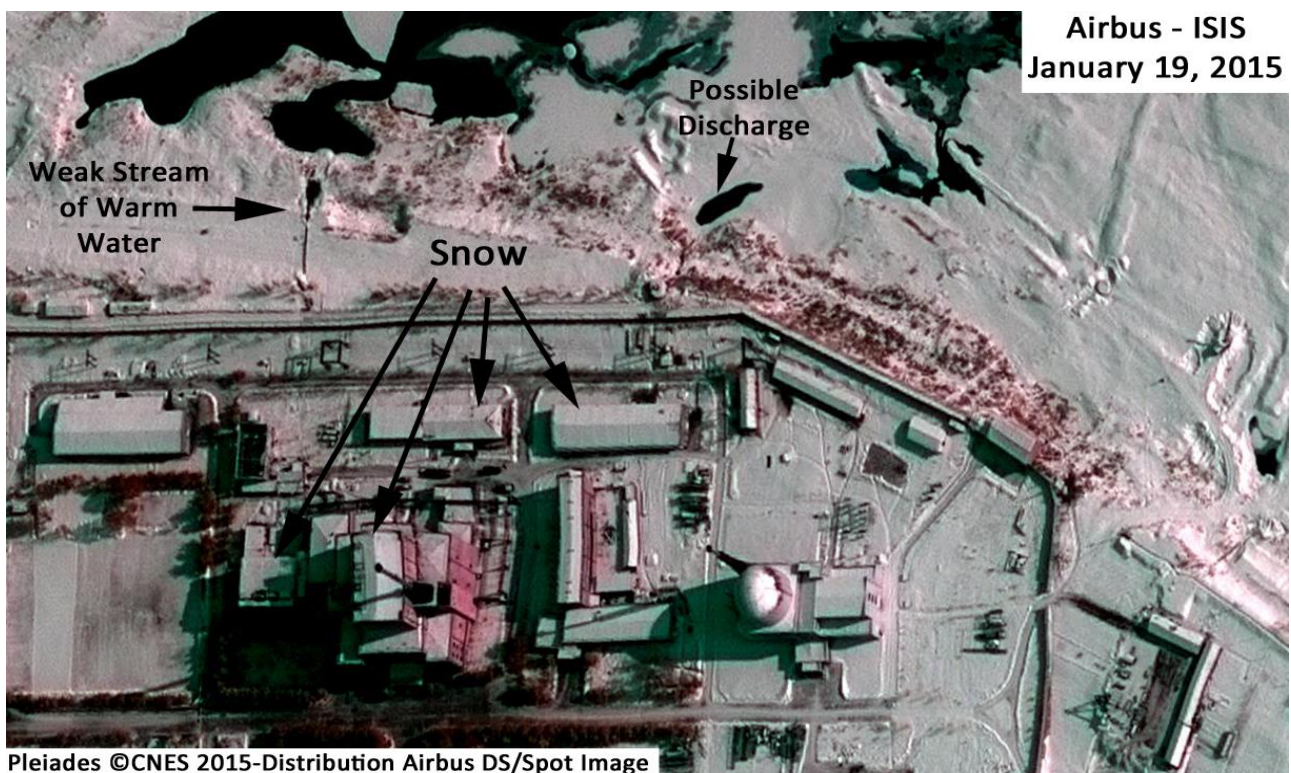
This assessment of partial operation derives from the analysis of melting snow patterns on the reactor and turbine buildings. On January 19, 2015, the site was covered in snow and there is very little indication of any melting, which could imply that it either recently snowed or the temperatures were too low for widespread melting (see figure 4). However, on February 6, 2015, the snow had melted in very specific areas at the site. For example, the snow on the roof of the 5MWe reactor had melted in an irregular manner compared to the snow on surrounding roofs (figure 3). This irregular melting could be caused by the combined effect of sun and heat from the inside of the building. In addition, little snow is present on the roof of the reactor's turbine building, again indicating that the inside of the building could be hot and therefore melting the snow on the roof.

Another important signature visible in the January 19 and February 6, 2015, images is the presence of a weak stream of warm water being discharged from the 5MWe reactor's discharge pipeline, which was identified when the reactor was operating prior to September 2014. It is important to note that this weak stream of water could have been present also in previous imagery but is only visible now because of the presence of snow and ice. The presence of this water signifies that the 5MWe reactor's secondary cooling

Figure 4. Airbus imagery showing the Yongbyon 5 megawatt-electric (MWe) reactor and experimental light water reactor on January 19, 2015. This is a color infrared image in which healthy vegetation appears red.

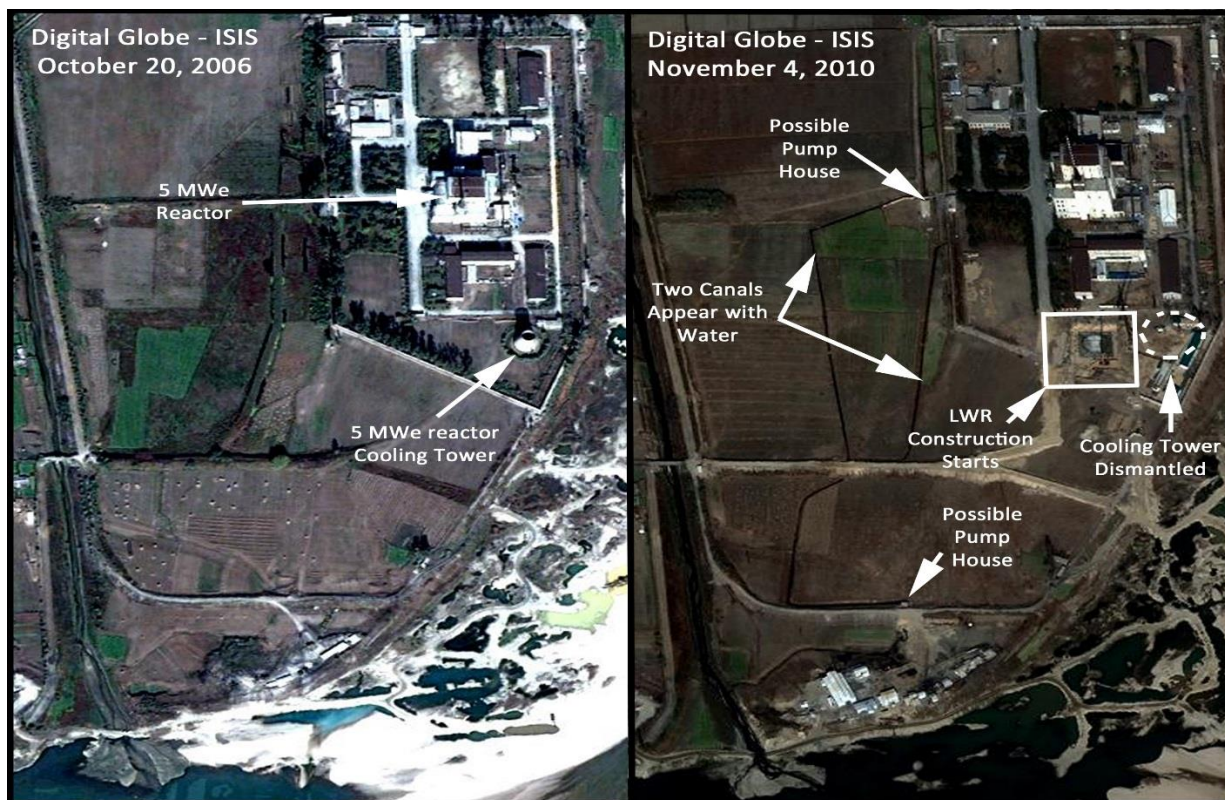
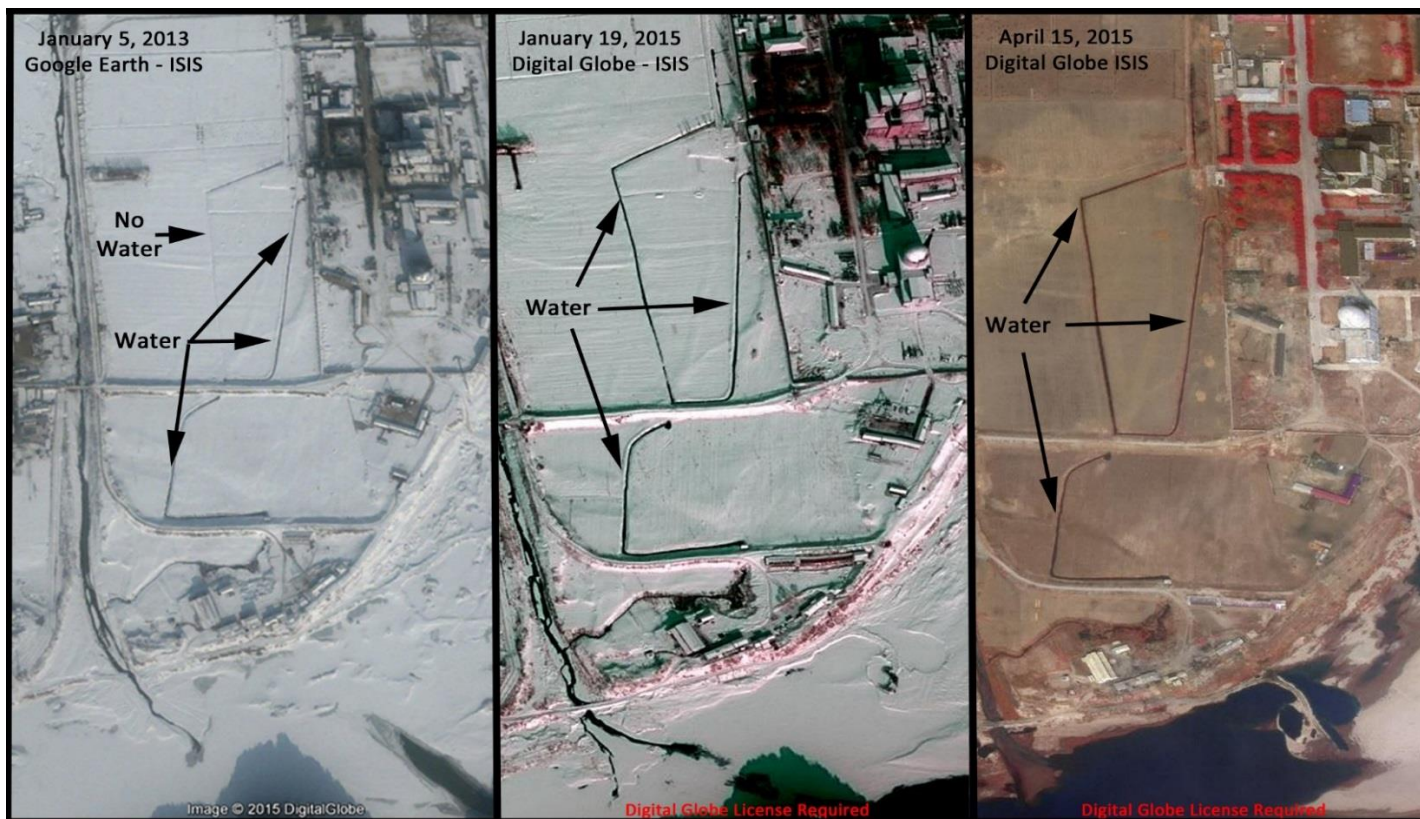
The second possible discharge location is on the other side of the reactors and involves two artificial water canals (see figures 1, 5, and 6). Although the precise origin of the water is unknown, the two canals seem to originate from the top half of the reactor site, which is where the 5 MWe reactor is located. The two canals converge and then flow under a road toward what may be a small pump house before ending at the river. A historic analysis shows that the canals were created at the time when light water reactor (LWR) construction started (note that the 5 MWe reactor's cooling tower had also been destroyed). Also, as figure 6 shows, the water in these canals was not always present. For example, in January 2013 there was water only in one of the two canals while in January and April 2015 water is present in both. The fact that water is visible in winter imagery (with snow and ice) suggests that the water is either flowing or is warm.

Figure 5 and 6. Digital Globe imagery showing a possible alternative discharge route for North Korea's Yongbyon 5 megawatt-electric (MWe) and experimental light water reactors.

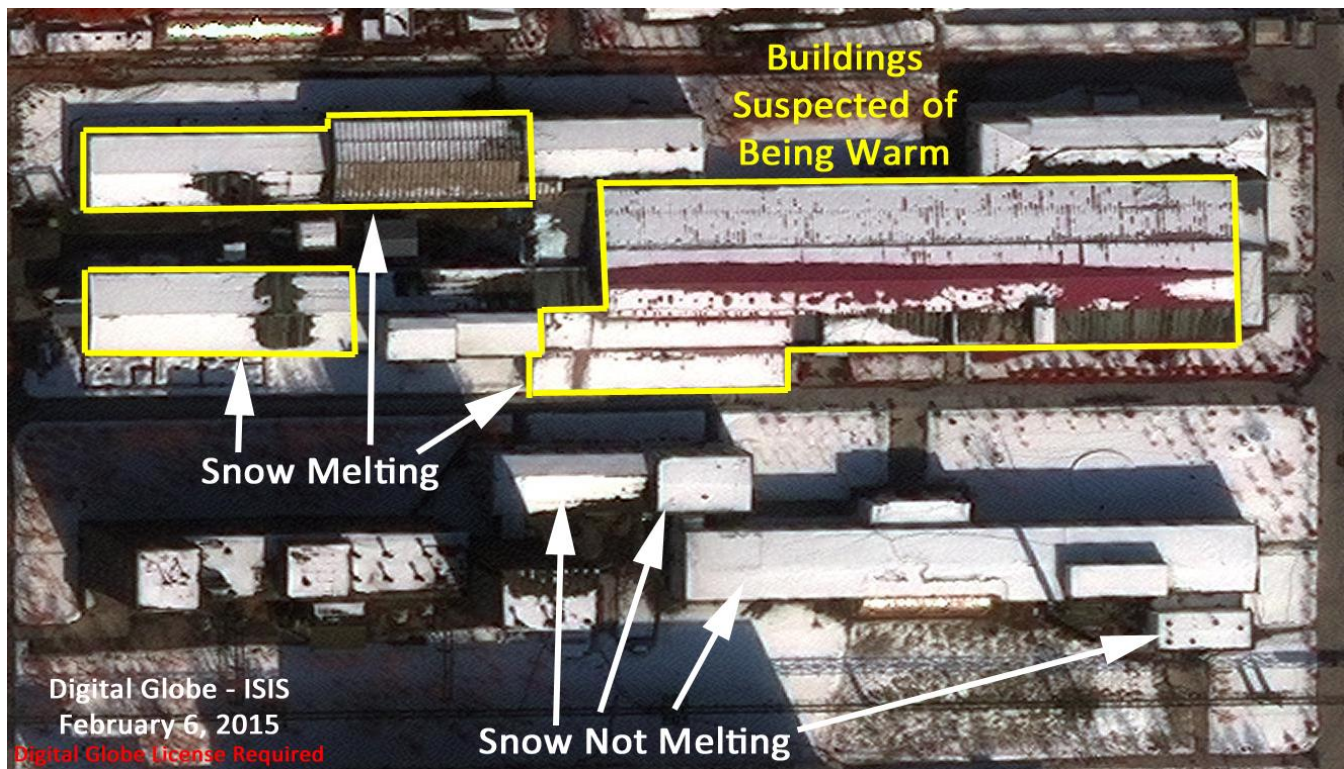
No new external activities have been detected in the immediate vicinity of the gas centrifuge plant located at the fuel fabrication complex in the southern part of the Yongbyon nuclear site. However, as above, the presence of snow in the February 6, 2015 image allows for the observation of one additional signature (see figure 7). The snow on the roof of the main centrifuge building and the two buildings to its left (one of which has a new roof) has melted faster and in an irregular manner compared to the surrounding buildings. This could be due to the effect of the sun (which would be expected to affect more of the buildings at the site) combined with heat being emitted from inside the buildings. It is plausible to assume that North Korea is heating the inside of the centrifuge hall in order to assure the correct functioning of the machines, which

are delicate and usually require a stable temperature of about 23° C (75° F). In addition, when looking at the main centrifuge hall, the side that presents less snow on the roof is known previously to have held centrifuge cascades and autoclaves, which are used to heat the uranium hexafluoride into a gas prior to its entry into the cascades. The other half of the building, where the roof remains snow covered, has been constructed in the last few years. The centrifuges and related equipment in this half may not yet be in full operation. Therefore, these signatures suggest that the older portion of the gas centrifuge plant has been operational and the newer part may not be.

Figure 7. Digital Globe and Airbus imagery showing the status of North Korea's Yongbyon Fuel Fabrication Complex on February 6, 2015.

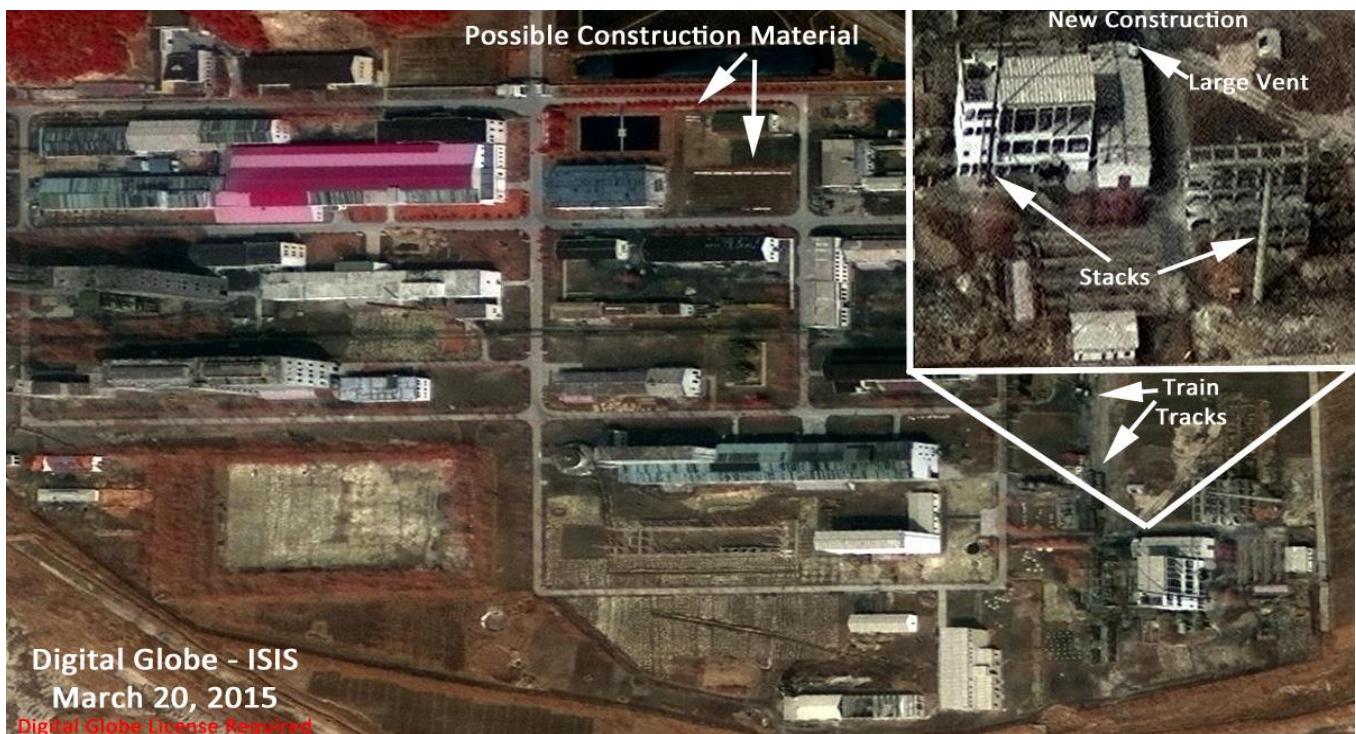
Imagery from March 20, 2015 shows eight 8 meter by 1 meter (height unknown) white objects in an open area across the road from the main enrichment building (figure 8). ISIS highlighted the presence of similar-shaped objects once before. In April 2014 similar objects were present in this specific location but were removed by June of the same year. The objects were believed to be construction material. In fact, In June 2014, as soon as these objects were removed, renovations of a roof adjacent to the main centrifuge hall started (see [here](#)). As of April 15, 2015, there are 44 of these objects (figure 9). It is possible that North Korea is preparing to renovate new roofs or buildings in the vicinity.

It is also worth noting that a substantial amount of construction has been taking place at a location adjacent to the train tracks that connect the fuel fabrication complex to other locations within the Yongbyon nuclear complex (see figures 8 and 9). A historical analysis of the location showed that as of 2002, two buildings and a stack were present in this area but they were completely demolished between 2003 and 2009. The construction of the new buildings started in early 2010. Prior to 2003, these buildings were believed to have been devoted to supporting activities, according to a former senior UN official close to the IAEA who had frequently visited the site when the Agreed Framework was in effect. The new buildings are significantly different than the demolished ones. In the recent imagery dated March 20 and April 15, 2015, a three story building is visible that is undergoing construction immediately adjacent to a shorter rectangular-shaped one. The taller building has a stack and several possible vents on the roof, while the shorter one seems to have an entrance connected to the train tracks and a large object on the roof, possibly a large vent. There are also foundations for what appear to be three additional buildings. A larger stack is also visible nearby. The presence of stacks suggest the release of harmful gases. There are also new tanks, e.g. behind the new three-story building, that suggest processes using chemicals. However, the precise purpose of these buildings is unknown.

Figure 8. Digital Globe imagery showing the status of North Korea's Yongbyon Fuel Fabrication Complex on March 20, 2015. (The close-up has been rotated 90 degrees to ease visualization of the buildings.)

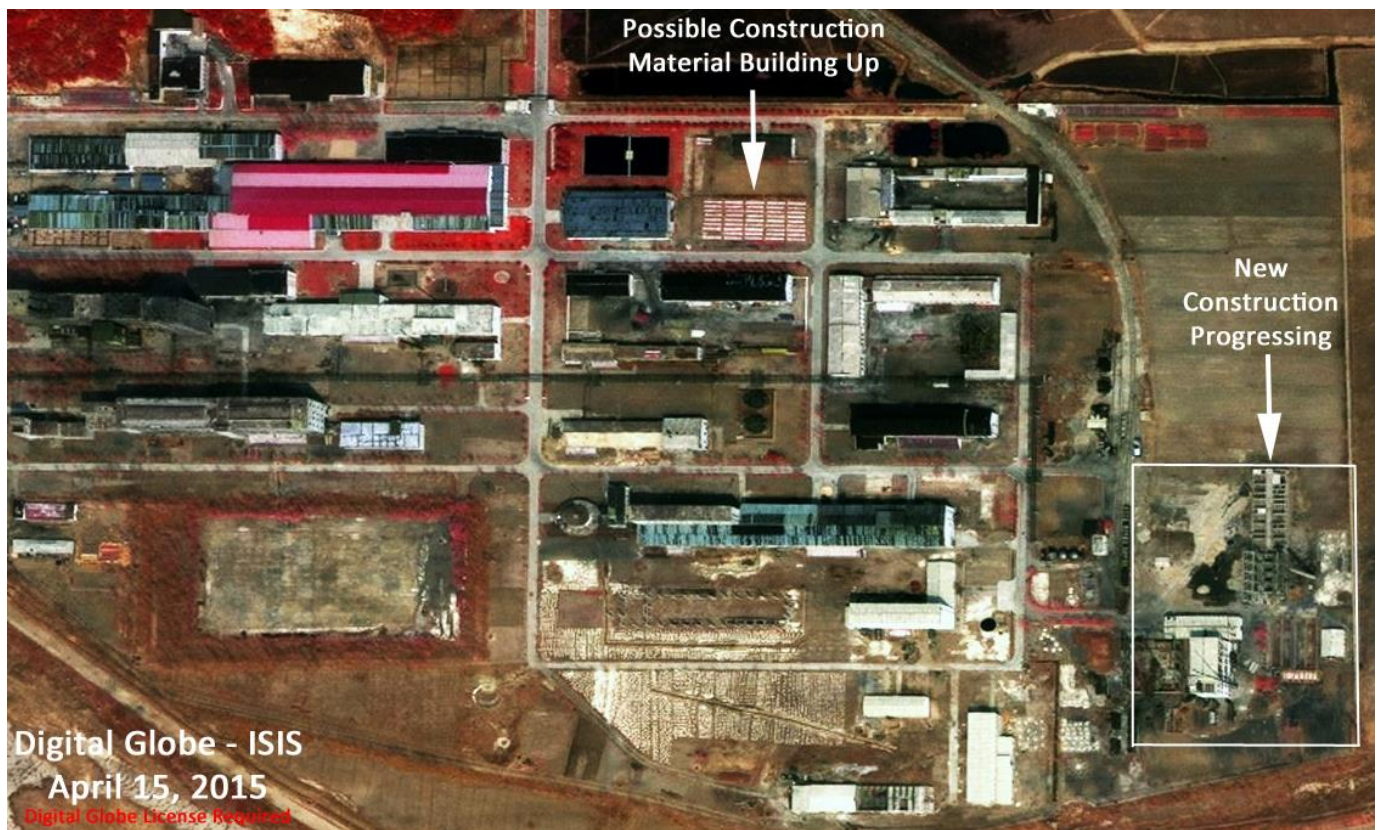
Figure 9. Digital Globe imagery showing the status of North Korea's Yongbyon Fuel Fabrication Complex on April 15, 2015.
